Machinery Messages

TDM 2 helps diagnose a crack on a charge gas compressor

by **Fabio H. G. Martins**
Maintenance Engineer
Petroquímica União S.A.
and
Rolando G. Dias
Manager/MDS Engineer
Bentley do Brasil Ltda.

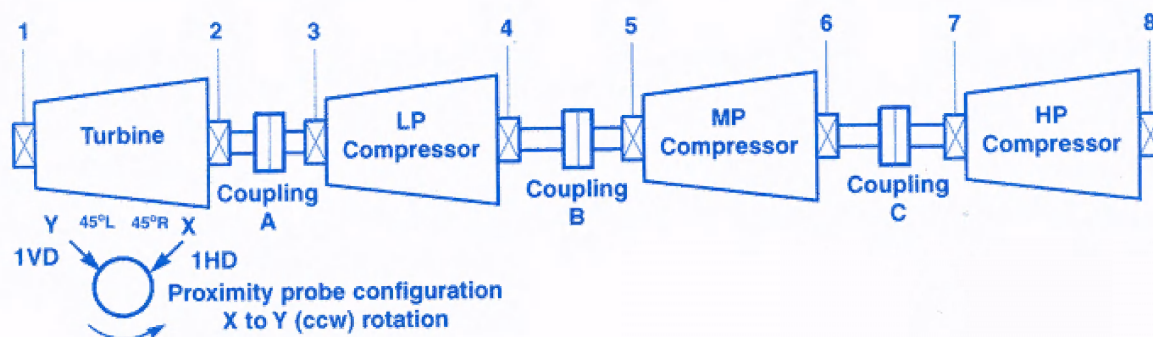
Figure 1
Machine train diagram.

The couplings are gear type, so the power is transmitted between rotors by gear teeth. Small axial displacements, due to load variation and thermal expan-

sion, as well as residual misalignment, are absorbed by the couplings.
